# The Keck Group, Inc.

## *The Basilica of St. Patrick's Old Cathedral*

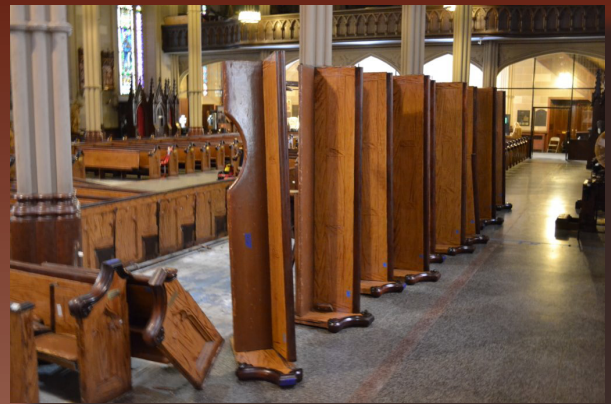
*The pews were removed from Old St. Pat's in September of 2014 for a yearlong church restoration. Note the divider wall from front to rear (which prevented parishioners from sliding through).*

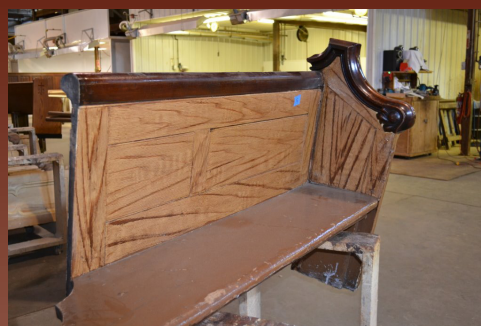
*After disassembly, the pieces had the many years of paint and finish removed.*

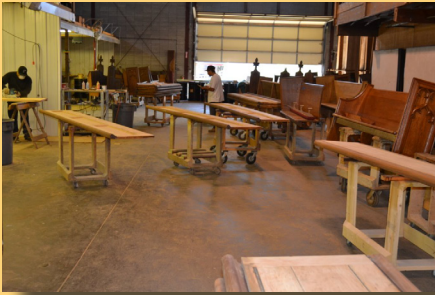
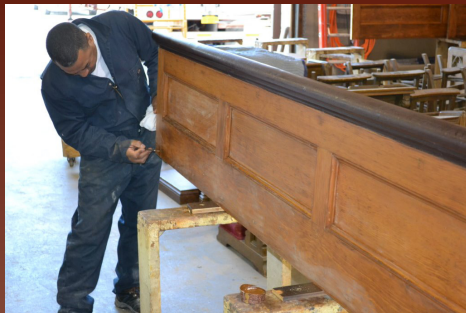
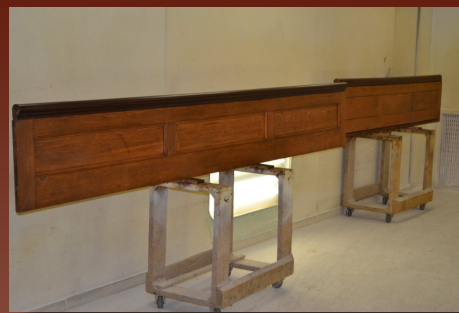
*All of the original and modified parts were finished. We waited to assemble until we got the six week warning.*

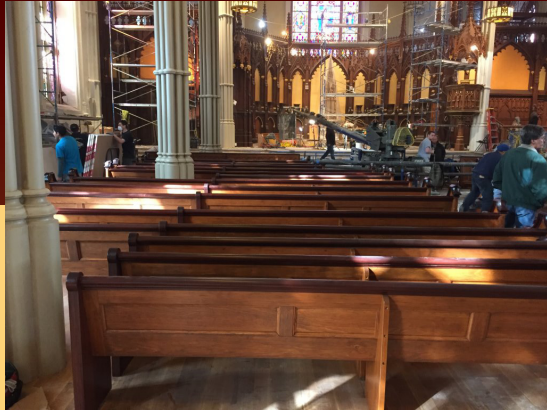
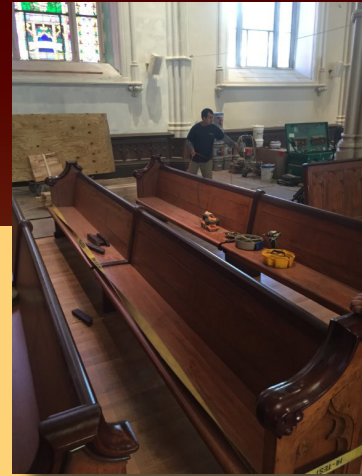
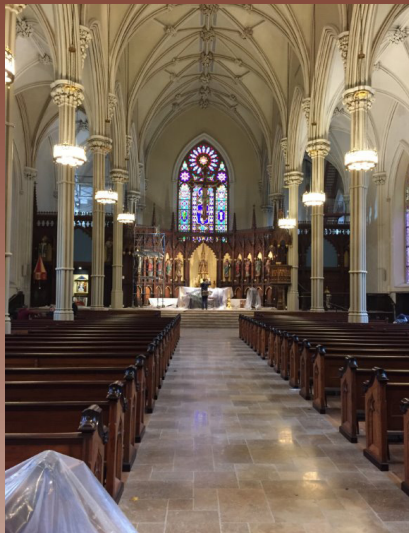
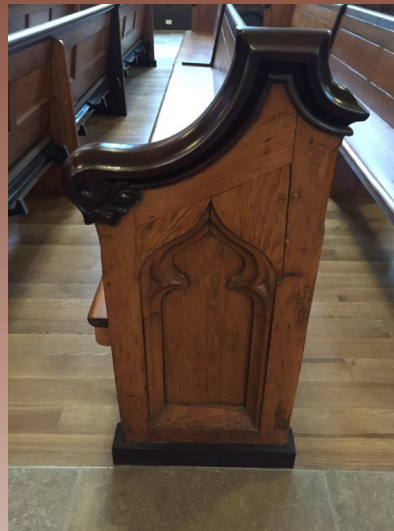
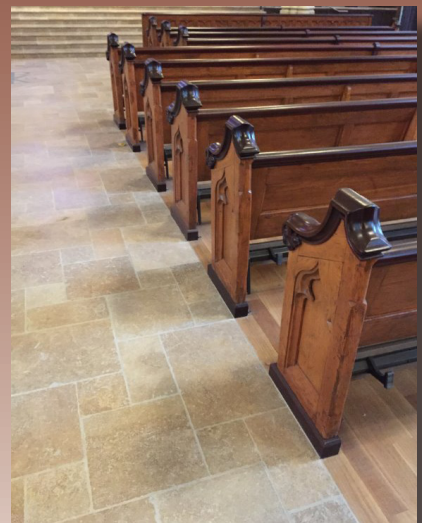
*These are the photos of the installation just prior to the dedication on Sunday November 15th, 2015.*
